Masonry vaults reinforcement with FRCM-PBO: conservative and structural issues

Masonry vaults strengthened with FRCM-PBO: the case of Palazzo APE Parma Museo

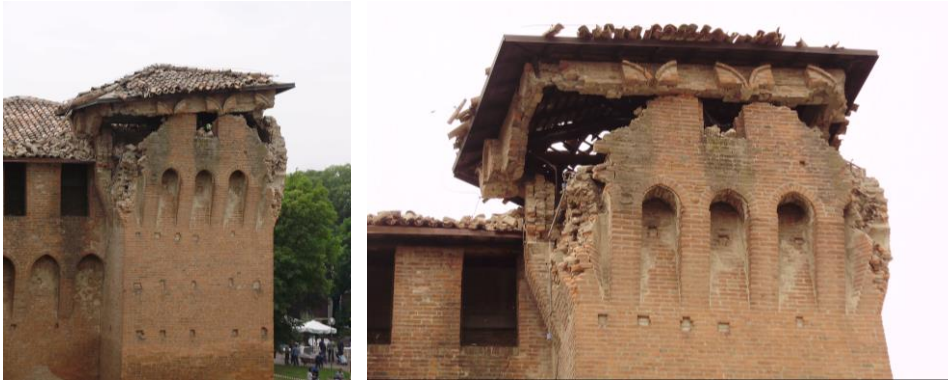
*Fig.1 San Felice sul Panaro fortresses:
effect of seismic action on merlons reinforced with excessively rigid ribs.*

some of the previous reinforcements, carried out according to generic technical indications, did not achieve a real safety increase [3]. This misalignment between the expected behavior and the real one is more evident when new materials, such as reinforced concrete elements cast in the 70s-80s, were employed [4]. The replacement of traditional timber roofs with reinforced concrete structures, the insertion of excessively rigid ribs at the top of the masonry walls (Fig.1), the use of stitching (in Italian “*cuciture armate*”) instead of traditional metal tie rods have often resulted in a greater damage for the building if compared to the probable disorders expected with the previous structure.

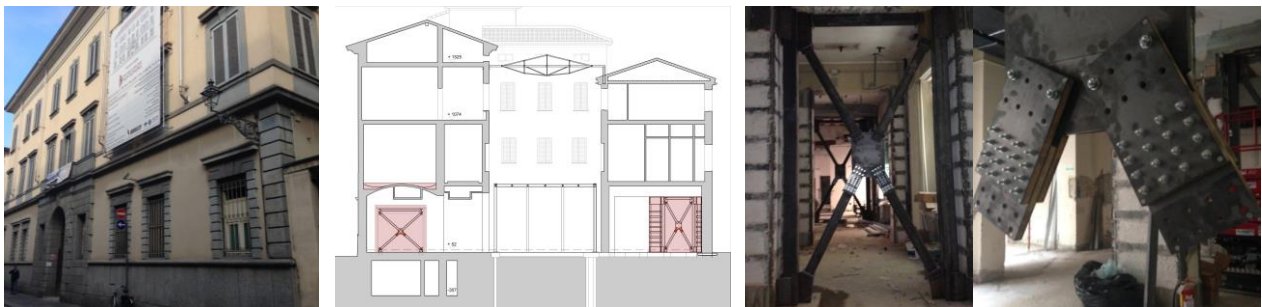
Fig.2 Seismic improvement: (a) Palazzo APE Museo in Parma; (b) cross section of the structure with strengthening interventions; (c,d) brick columns jacketing and Meldamp ® damping system.

The palace (Fig. 2a), located near the main square of the city center, was built in the medieval period. Since then, several modifications – occurred over centuries – transformed this masonry construction into a richly decorated renaissance building. Ex-seat of Banca d'Italia from the beginning of 20th century, in 2015 the palace undergone restoration works to become a contemporary cultural center and Fondazione Monte Parma seat. The masonry building did not show a severe crack pattern, since it was limited at the interaction points between the original masonry walls and the reinforced concrete addition. However, the interventions carried out in 1955 altered the original structural configuration: the demolition of some walls at the raised floor generated discontinuities in the vertical masonry elements, weakening the structure in case of occurring earthquakes. Seismic improvements (Fig. 2b) were therefore required to avoid local damages and improve the overall masonry behavior. The strengthening techniques were chosen in order to improve the capacity of the masonry system without excessively increasing stiffness or seismic loads.

First of all, the vulnerabilities caused by previous interventions were solved by means of steel jacketing to strengthen masonry columns at the raised floor (portions of masonry walls demolished in 1955) and by means of a steel bracing damping system (Meldamp®) to increase resistance allowing energy dissipation without significantly increase structural stiffness (Fig. 2c).

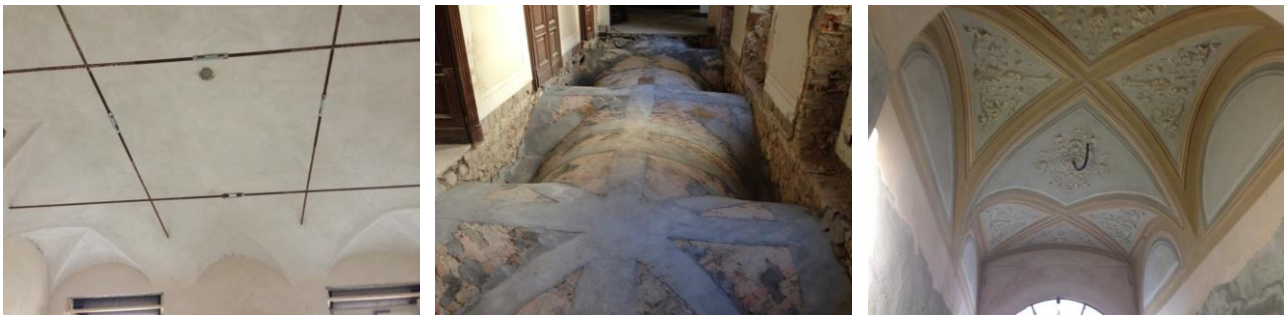
Fig.3 Masonry vaults reinforcement: (a) insertion of tie-rods; (b) FRCM-PBO system applied at the extrados; (c) Frescos at the intrados of cross-vault.

Moreover, to reinforce historic masonry vaults, metal tie-rods (Fig.3a) were inserted at the intrados and/or composites systems were applied at the extrados (Fig.3b). Note that, since the vaults intrados is frescoed (Fig.3c), the composites strips were applied straight along the tensile load path, reducing at the minimum the covered area.
